REPAIR OF EARTHQUAKE DAMAGED CHIMNEYS

To facilitate the repair of chimneys the Building Division of the City of Santa Clara has approved the following procedures and details. Any of the appropriate details may be used.

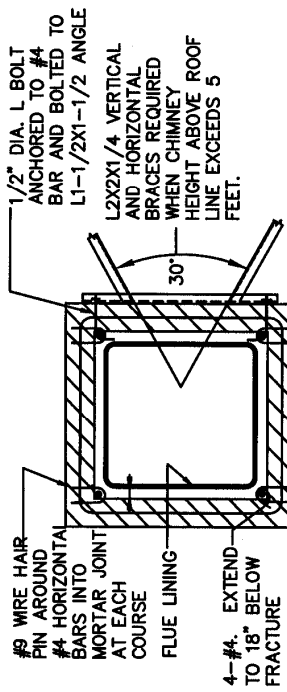
DETAIL A-1

NOTE: THIS DETAIL MAY BE USED WHEN FRACTURES OCCUR 1' ABOVE ROOF LINE

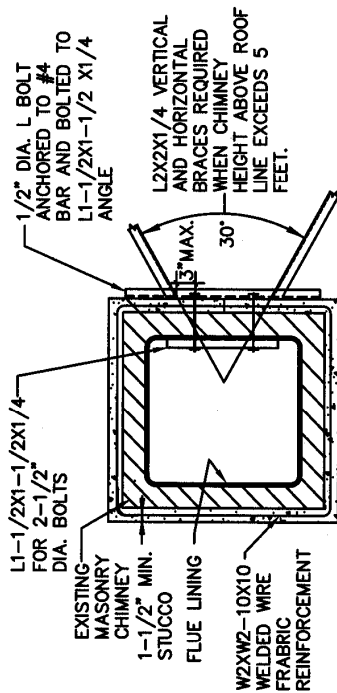
DETAIL A-2

NOTE: THIS DETAIL MAY BE USED WHEN FRACTURES OCCUR 1' ABOVE ROOF LINE

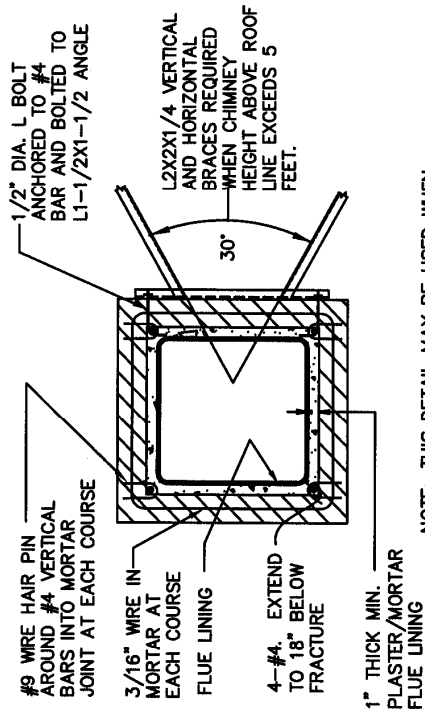
DETAIL A-3

NOTE: THIS DETAIL MAY BE USED WHEN FRACTURES OCCUR 1' ABOVE ROOF LINE

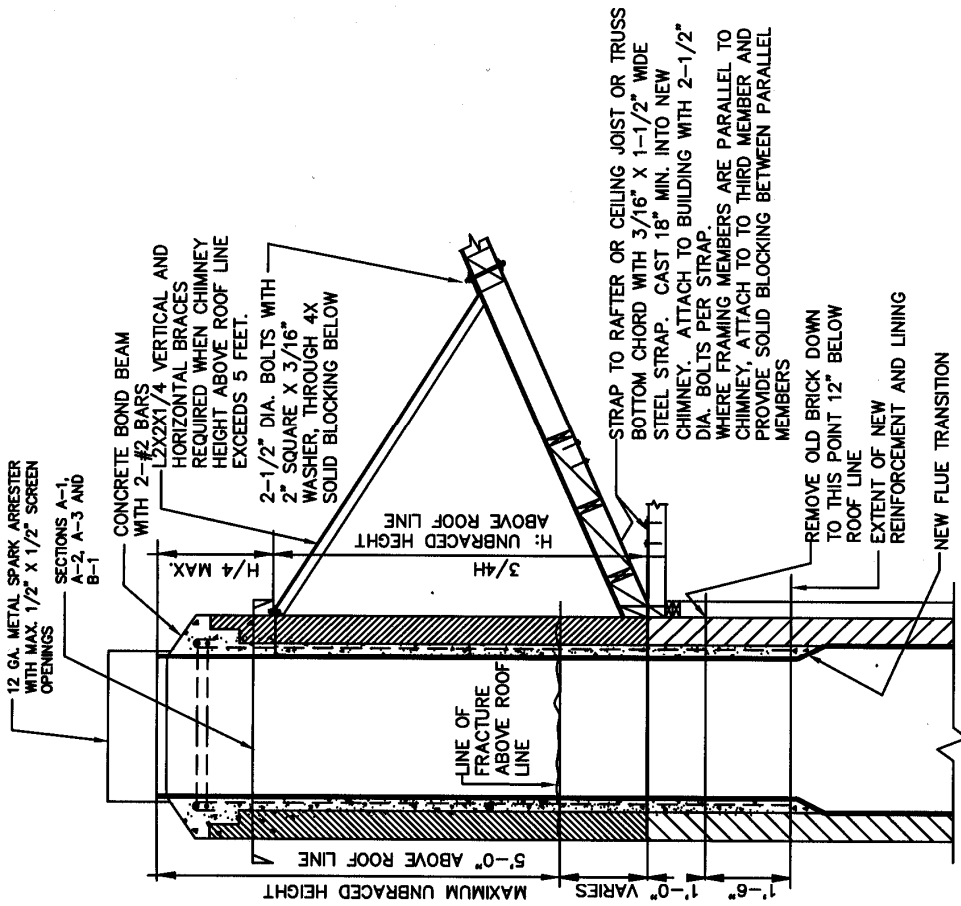
VERTICAL SECTION A

RECONSTRUCTION OF MASONRY CHIMNEYS FRACTURED ABOVE ROOF LINE

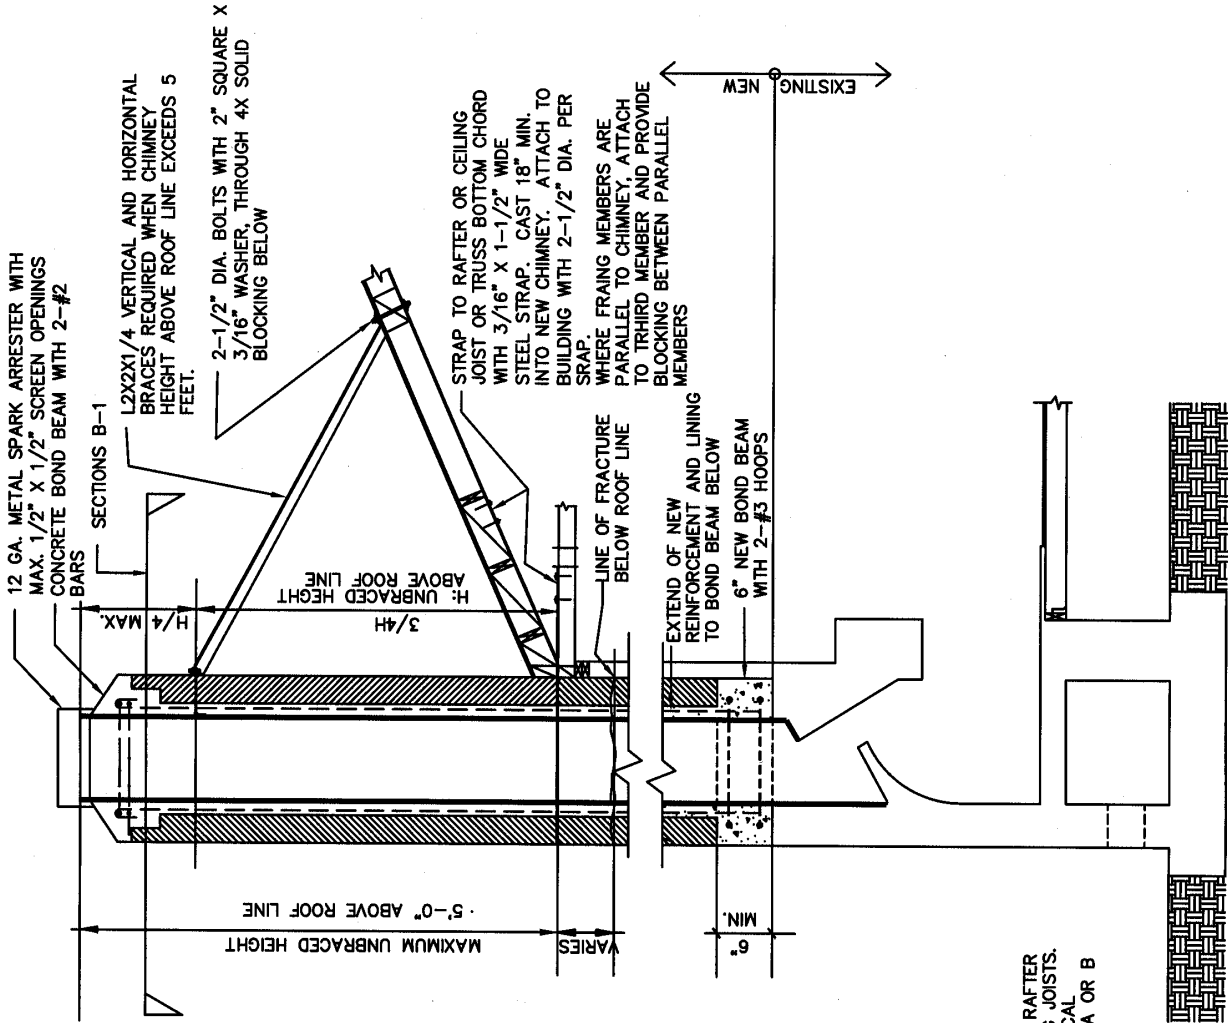
RECONSTRUCTION OF MASONRY CHIMNEYS FRACTURED BELOW ROOF LINE
VERTICAL SECTION B

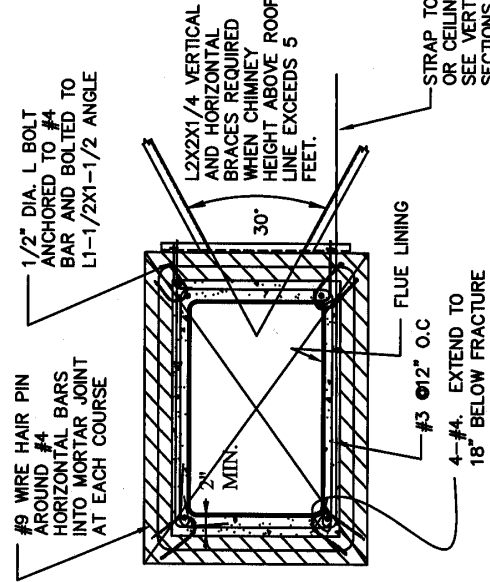
DETAIL B-1

NOTE: THIS DETAIL MAY BE USED WHEN FRACTURES OCCUR ABOVE ROOF LINE PROVIDED EXISTING CHIMNEY IS DOUBLE COURSE CONSTRUCTION
