Phase I Environmental Site Assessment

Centennial Boulevard Site
Santa Clara, California

49ers Stadium, LLC
4949 Centennial Boulevard
Santa Clara, California 95054

May 2008

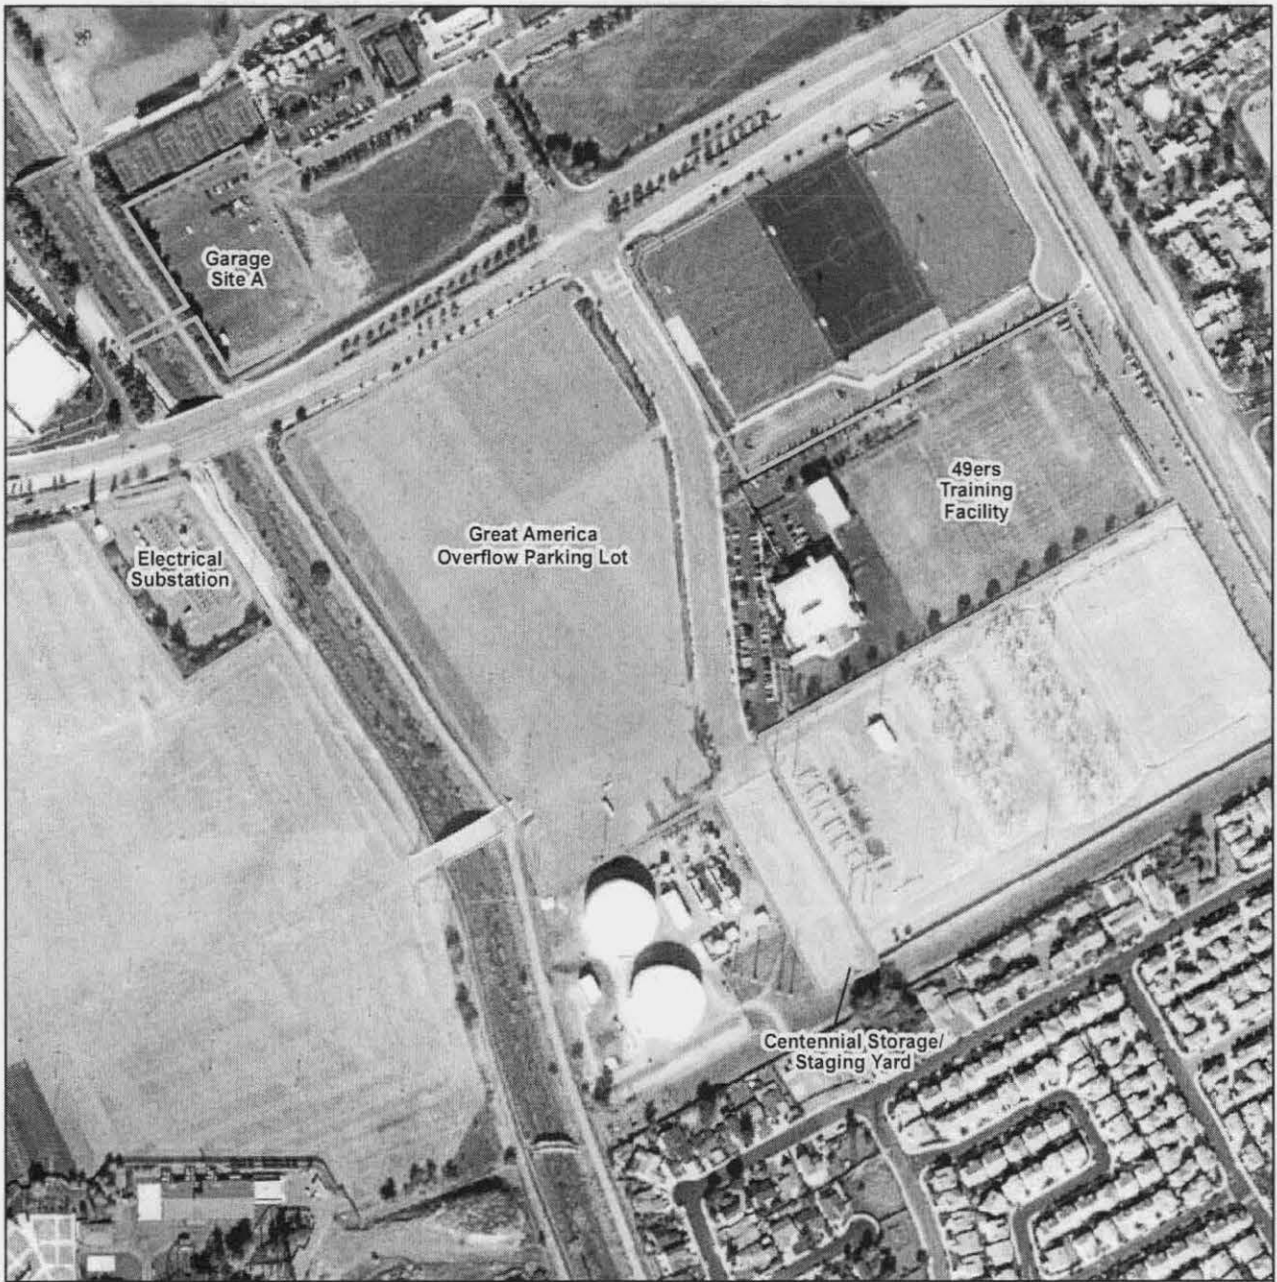
Figure 2

The site consists of ten parcels totaling approximately 39 acres located in the North Bayshore area of the City of Santa Clara in the Santa Clara Valley (Figure 1). The site includes the overflow parking lot for the Santa Clara Golf and Tennis Club and the Santa Clara Convention Center (referred to as Garage Site A), the City of Santa Clara electrical substation on Tasman Drive, the Great America overflow parking lot, a small portion of the City of Santa Clara Youth Soccer Park, the 49ers training facility, and the Centennial storage/staging yard (Figure 2). The site is bordered to the north by Tasman Drive and the former Santa Clara Landfill, which is now the Santa Clara Golf and Tennis Club; to the northeast by an industrial park; to the east by Lafayette Street; to the south and southeast by the Silicon Valley Power Northern Receiving Station, the Gianera Power Plant, two City of Santa Clara aboveground water storage tanks, and the Hetch-Hetchy Regional Water System right-of-way; and to the west by the San Tomas Aquino Creek, Great America theme park, and the Santa Clara Convention Center (Figure 3).

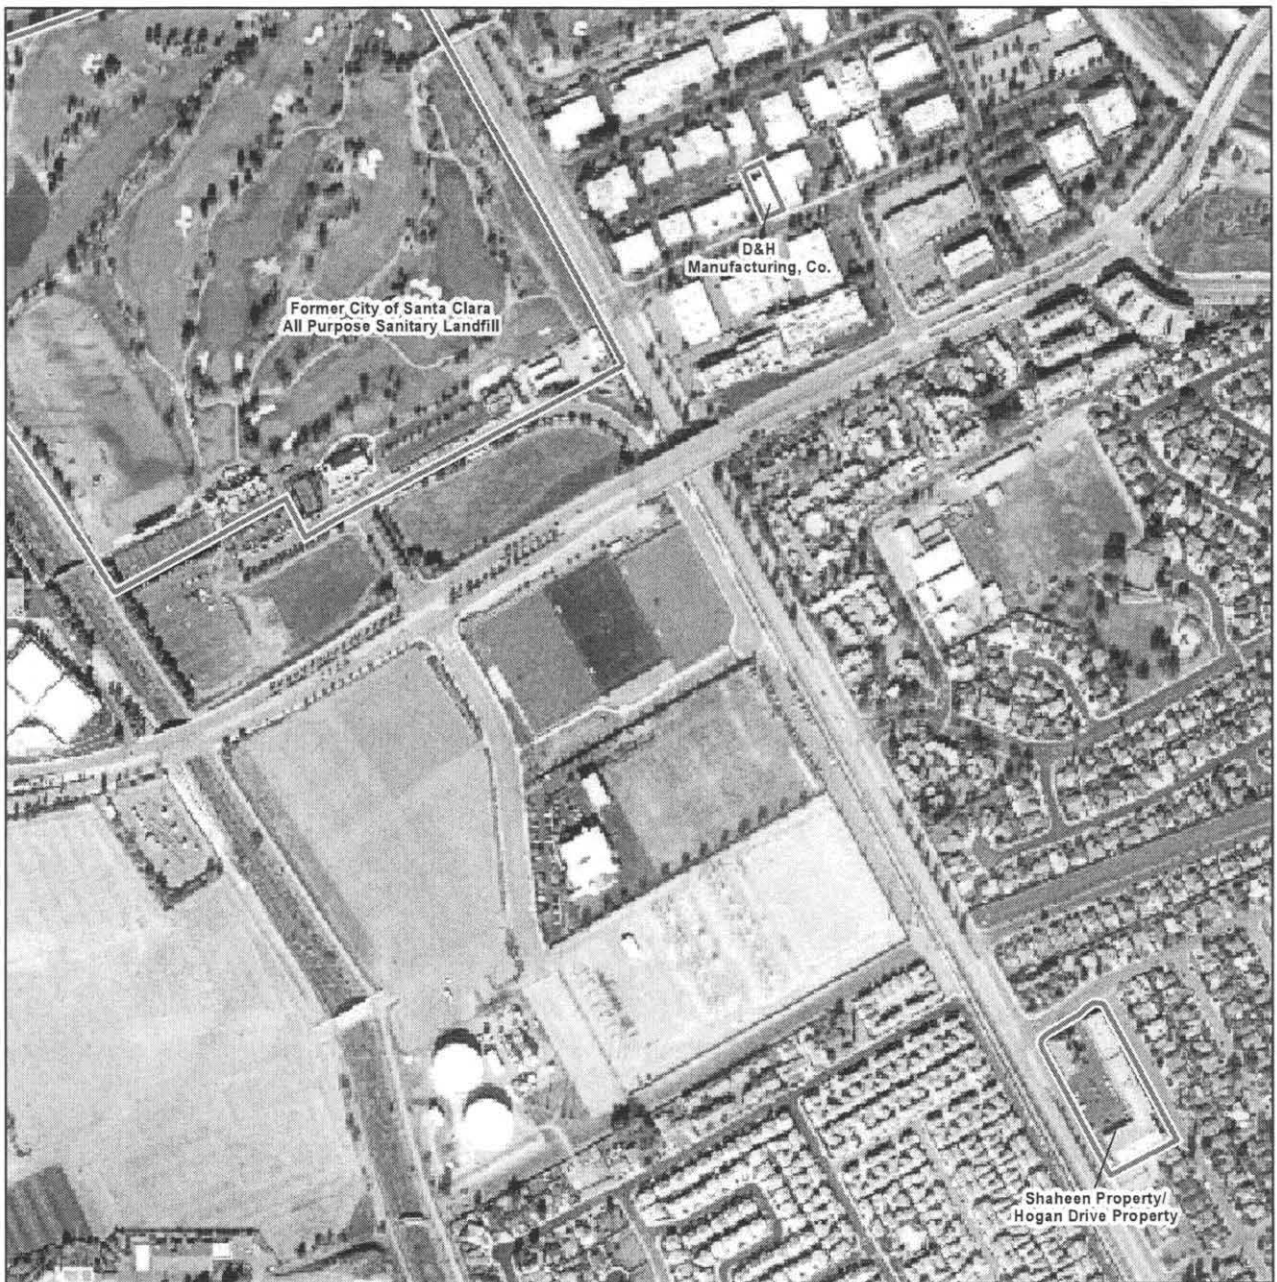
Additional information was provided by Mr. Wasson of the 49ers from his search on the U.S. EPA’s Envirofacts database. Geomatrix also conducted an online data base search of the Water Board’s Geotracker database and the DTSC’s Envirostor database. The information reviewed in the case files made available by these agencies and in the EDR report and online databases is summarized below and in Table 1. The locations of off-site properties with reported releases to soil and/or groundwater that could have the potential to impact the site are shown on Figure 4.
