SCHOOL ZONE  
AT  
CLAREMONT AVENUE  
ON  
MAURICIA AVENUE

CLAREMONT AVE X-WALK

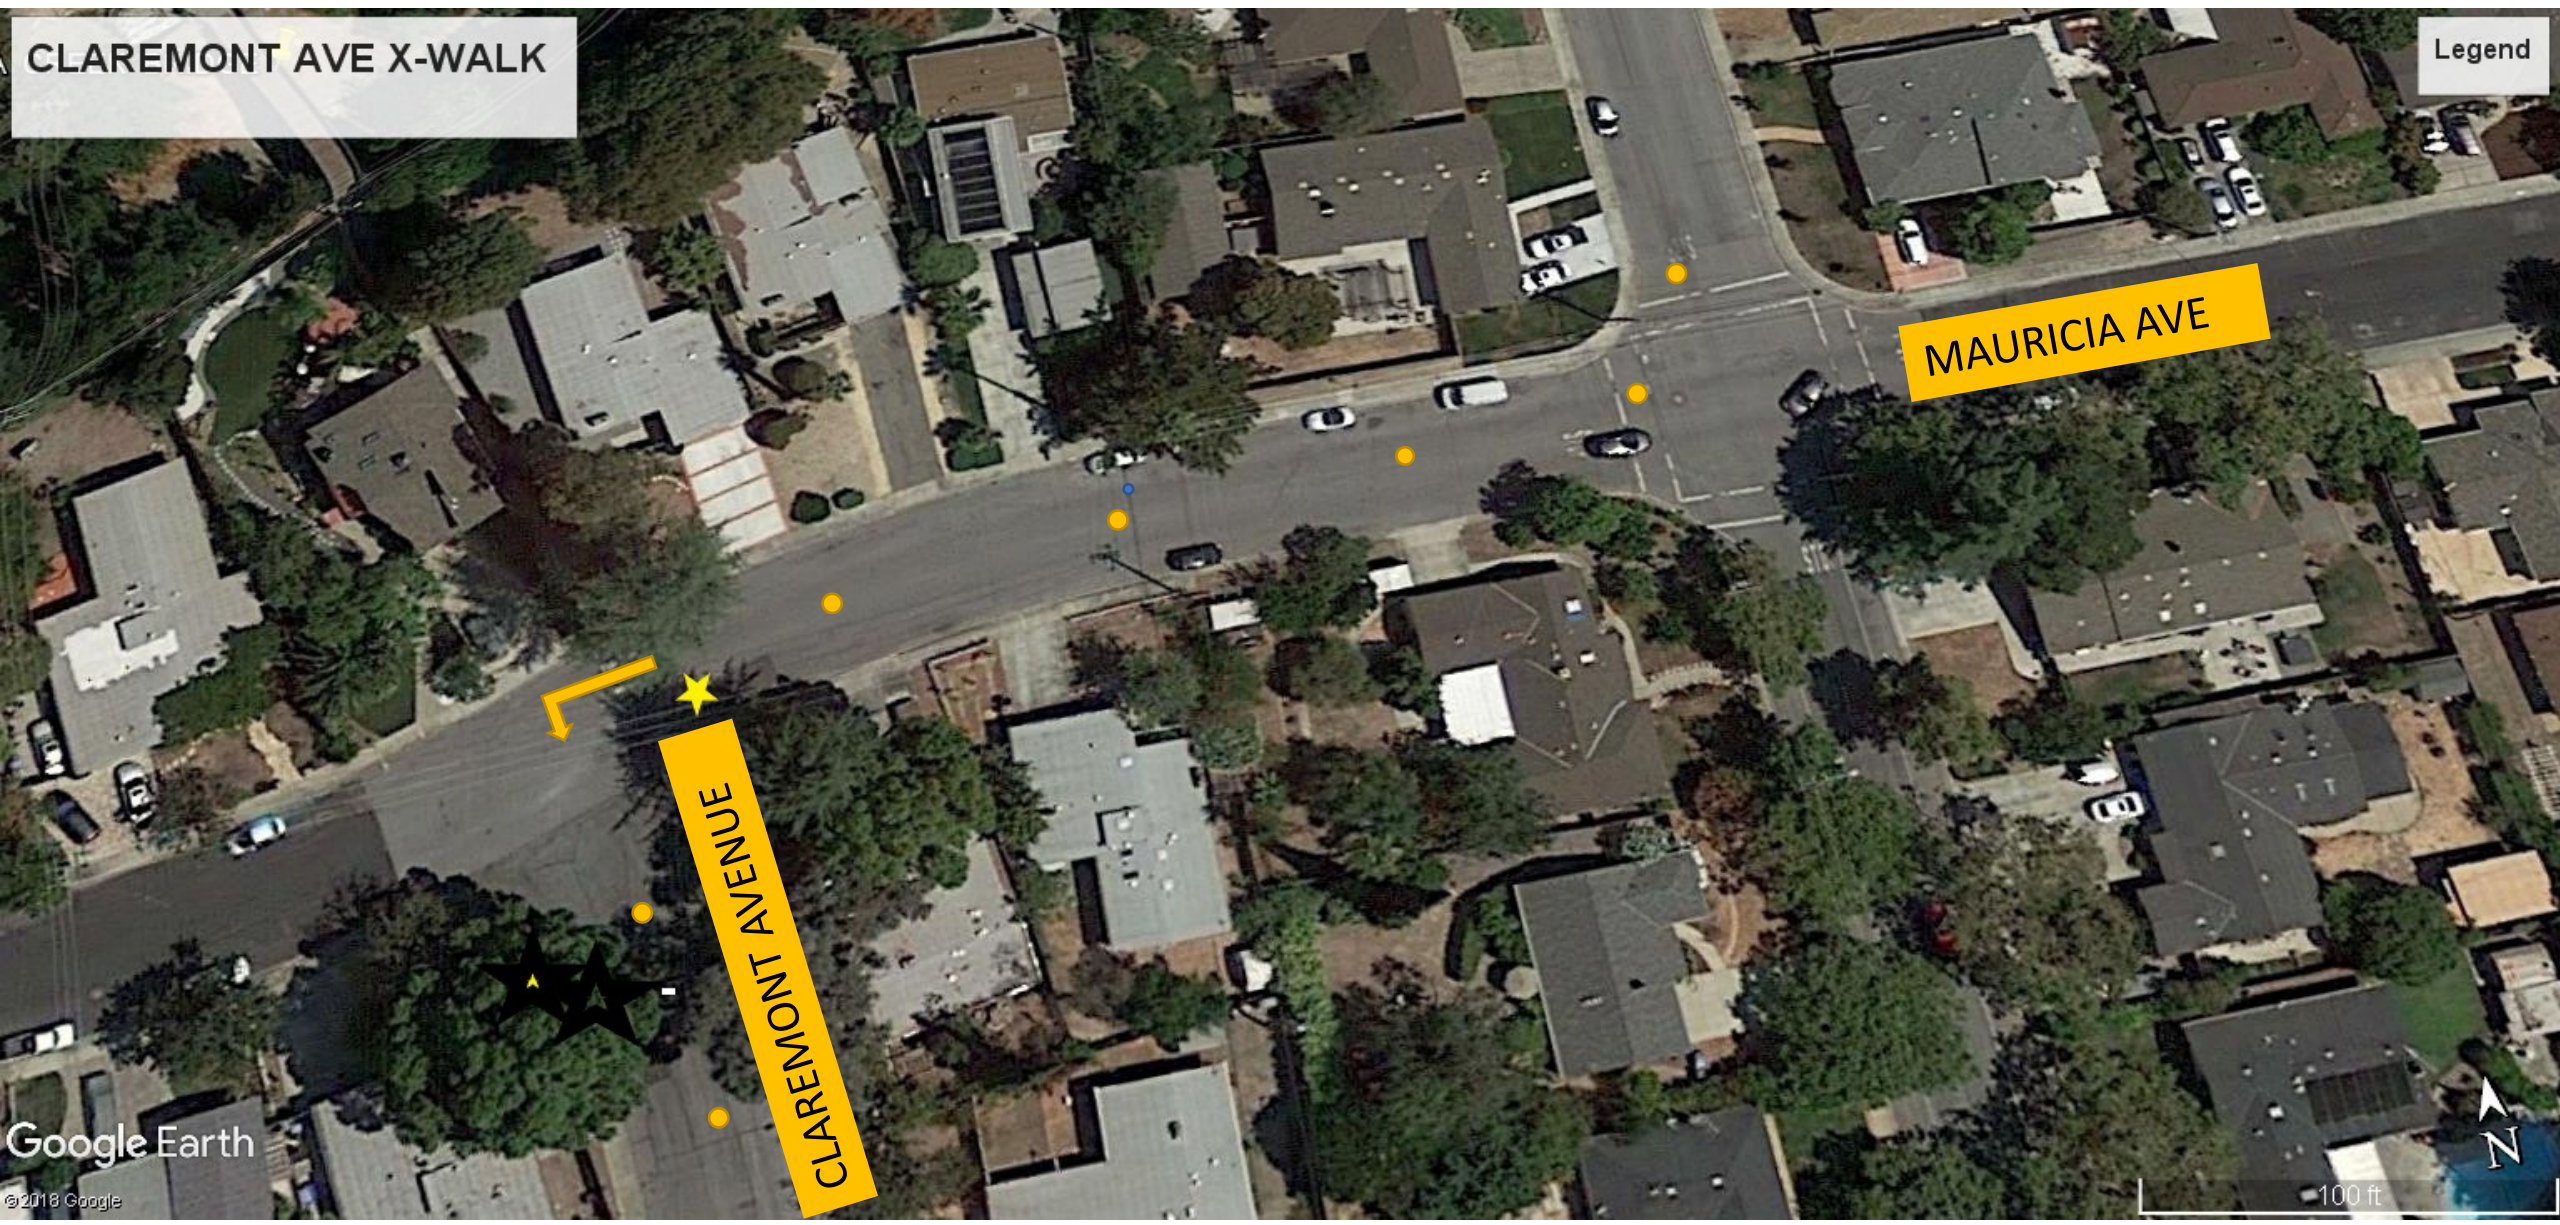
- 1. EISENHOWER SCHOOL VEHICLE ROUTE TO REACH THE TRAFFIC SIGNAL AT STEVENS CREEK BLVD.
- 2 MORNING AND AFTERNOON HEAVY VEHICLE TRAFFIC IS AT THE SAME TIME AS THE NEIGHBORHOOD CHILDREN ARE WALKING TO SCHOOL AND USING THE CROSSWALK
- 3. VEHICLE SPEED IS RELATIVELY HIGH AND VEHICLES CUT THE CORNER WITHOUT REGARD TO THE ROADWAY CENTERLINES.
- 4. THE INSTALLATION OF YELLOW “X-WALK” WARNING SIGNS HAVE NOT ADDRESSED THE SAFETY ISSUE

- 5. THE CROSSWALK IS OUTSIDE THE SCHOOL CROSSING GUARD ASSIGNMENT ZONE.
- 6. THE CROSSWALK STRIPING IS WELL WORN ON THE WRONG SIDE OF THE ROADWAY CENTERLINE. REVEALING THAT VEHICLE TRAFFIC CUTS THE CORNER.
- 7. THE MAURICIA AVENUE CROSSWALK IS THE ONLY ROUTE TO SCHOOL FOR 210+/-SINGLE FAMILY HOMES.

- 1. INSTALL A SECOND CROSSWALK ON THE WEST SIDE OF THE INTERSECTION ALLOWING A MAURICIA AVENUE CROSSING BEYOND THE HEAVY TRAVELED VEHICLE CONFLICT ROUTE.
- 2. REFRESH THE PAVEMENT MARKINGS FOR THE EXISTING CROSSWALK, AND INSTALL WARNING PAVEMENT MARKINGS BEFORE EACH CROSSWALK.
- 3. INSTALL A “CROSSWALK” BOLLARD AT THE ROADWAY CENTER @ THE EASTERLY CROSSWALK . THIS WOULD FORCE THE VEHICLE TRAFFIC TO SLOW DOWN AND NOT CUT THE CORNER.
